Manhole Inspection Summary

Manhole # S07QQ1012MH

Insp Date: **7/8/09 12:37 PM**

Location Address: **5216 PARK HEIGHTS AV**

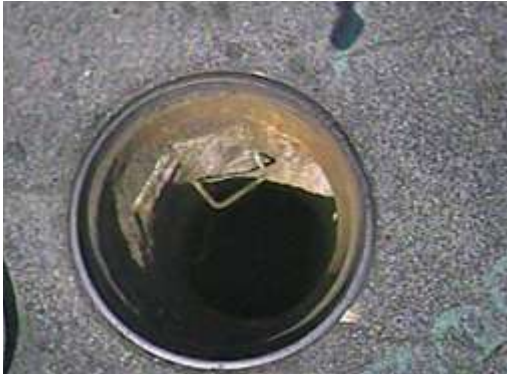
Top View

Offset: **4** (in.)

FRAME OFFSET

Mud seeping through cover

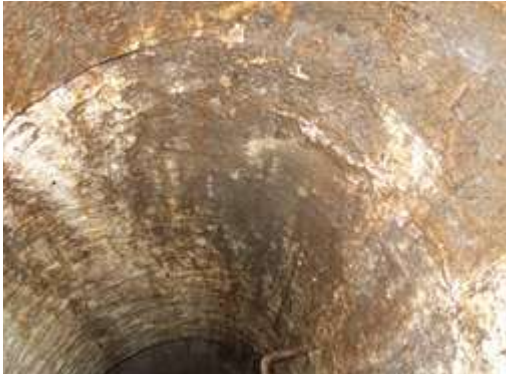
FRAME OFFSET

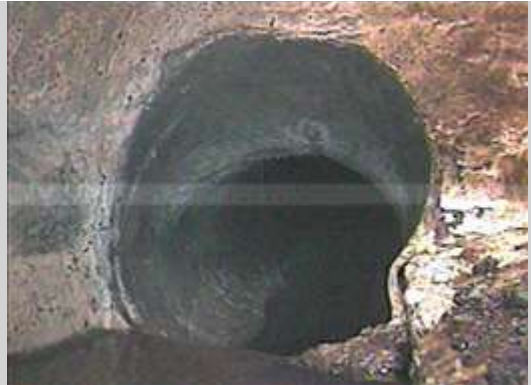
12 O'Clock Outflow

15 in. Circular Gravity Sewer
Pipe Out @ 12 O'Clock

Pipe Height: (in.) Direct
Pipe Material: **Clay** ☐ Pipe Lined
Invert Depth: **13.95** (ft.) Flow Characteristics: **Slow**
Deposits: ☒ None ☐ Mud ☐ Sludge ☐ Debris ☐ Grease
Silt Depth: (in.) Deposits Extent:
Infiltration: **None** Pipe Seal Cond: **Sound**

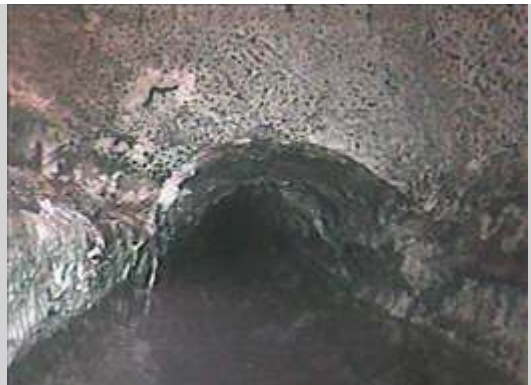
6 O'Clock Inflow

15 in. Circular Gravity Sewer
Pipe In @ 6 O'Clock

Pipe Height: (in.) Direct
Pipe Material: **Clay** ☐ Pipe Lined
Invert Depth: **14.19** (ft.) Flow Characteristics: **Slow**
Deposits: ☒ None ☐ Mud ☐ Sludge ☐ Debris ☐ Grease
Silt Depth: (in.) Deposits Extent:
Infiltration: **None** Pipe Seal Cond: **Sound**

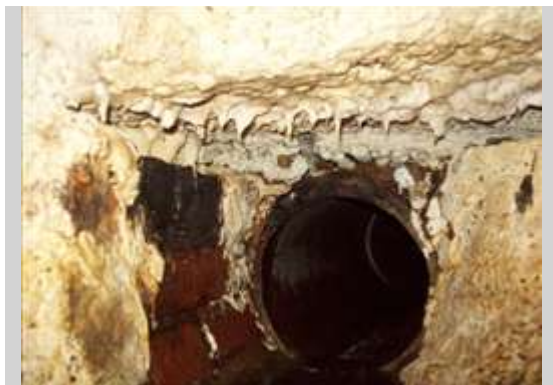
9 O'Clock Inflow

8 in. Circular Gravity Sewer

Pipe In @ 9 O'Clock

Infiltration: **None** Pipe Seal Cond: **Unknown**
